## **Two Unpaved Road Sections in Southern Manitoba Incorporating Tire Derived Aggregate Performance Evaluation**

**Project Number:** 0186 003 00

**Date:** September 9, 2026

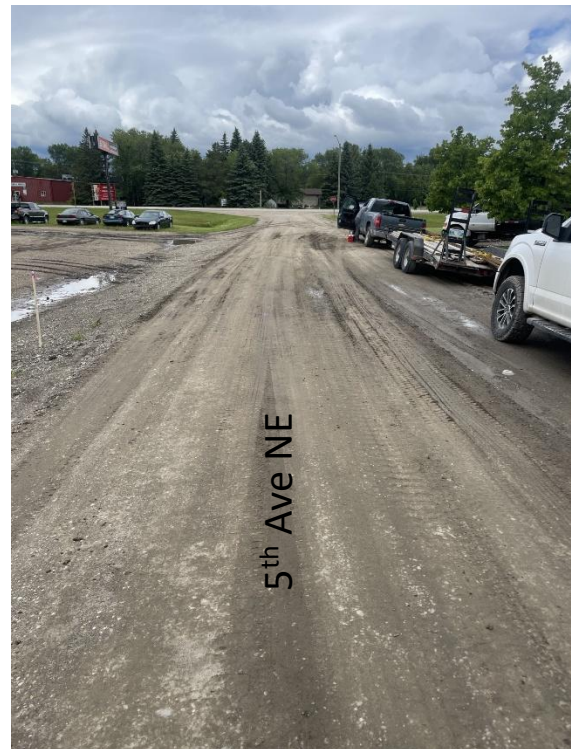
Figure 257. Rutting in problem area, view W

The Carman study area includes about 100 m of unpaved two-lane road within a commercial-industrial area along 5<sup>th</sup> Avenue NE, immediately east of Main Street North (PTH 13) as shown on Figure 1. There is a shallow ditch along the south side of the road with drainage to the west. Within the study area, there is about 30 m of roadway experiencing moderate rutting, referenced on Drawing 01 as the “problem area”. Rutting is shown on Figure 2.

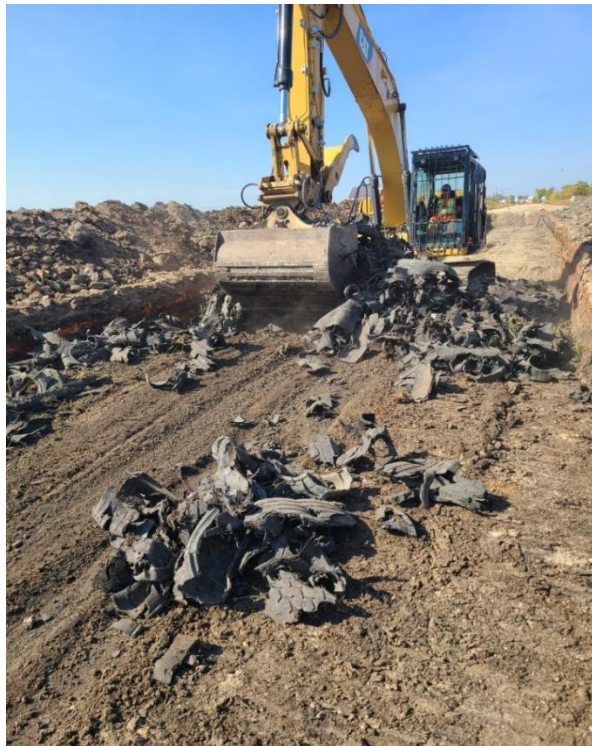
Figure 2221. Placing first lift of TDA in cut  
(photo courtesy of P. Schroedter)

1. The existing roadway was excavated over a width of approximately 7 m to a depth of approximately 2 m, centered on the roadway (referred to herein as the “cut”). Excavated material was windrowed adjacent to the cut.
2. Tire derived aggregate (TDA) was loosely placed directly on the subgrade within the cut in a 300 mm (12 inch) lift and compacted with seven passes of a track mounted excavator. A second 300 mm lift was placed in a similar fashion. The target degree of compaction was about 50% of the loose lift thickness (total thickness of approximately 300 mm).
3. The excavated material was placed in 300 mm lifts directly above the top lift of TDA and compacted with seven passes of the excavator. It is our understanding that the soil was very wet after significant rainfall.
4. A thin layer of sand and gravel fill or shale gravel was placed as a driving surface.

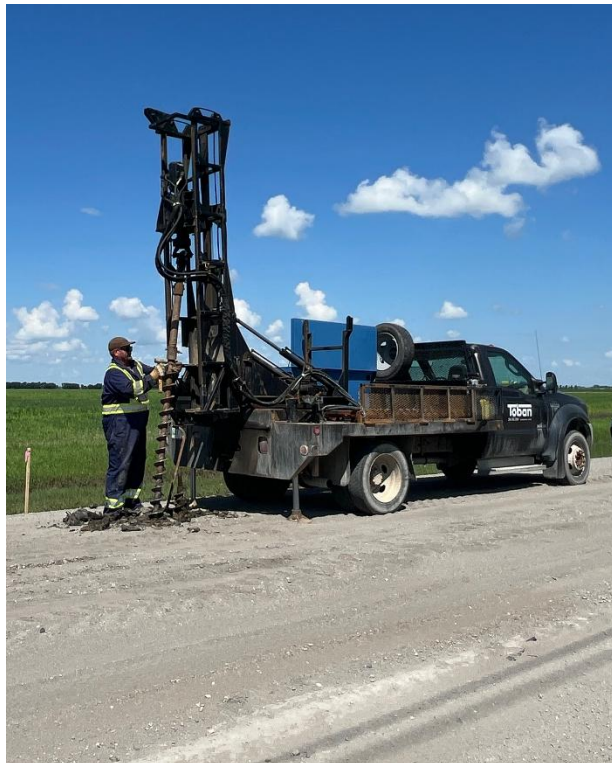
Figure 2941. Drill rig at Winkler Site

The sub-surface investigation was completed on July 8, 2026 under the supervision of TREK personnel. Test holes were drilled by Bicycle Consulting Ltd. using a truck-mounted drill rig equipped with 125 mm diameter solid stem augers (Figures 7 and 8). Eight test holes were drilled and sampled at the locations shown in Drawings 01 and 05 to a depth of 3.1 m. The test holes were backfilled with auger cuttings to surface.

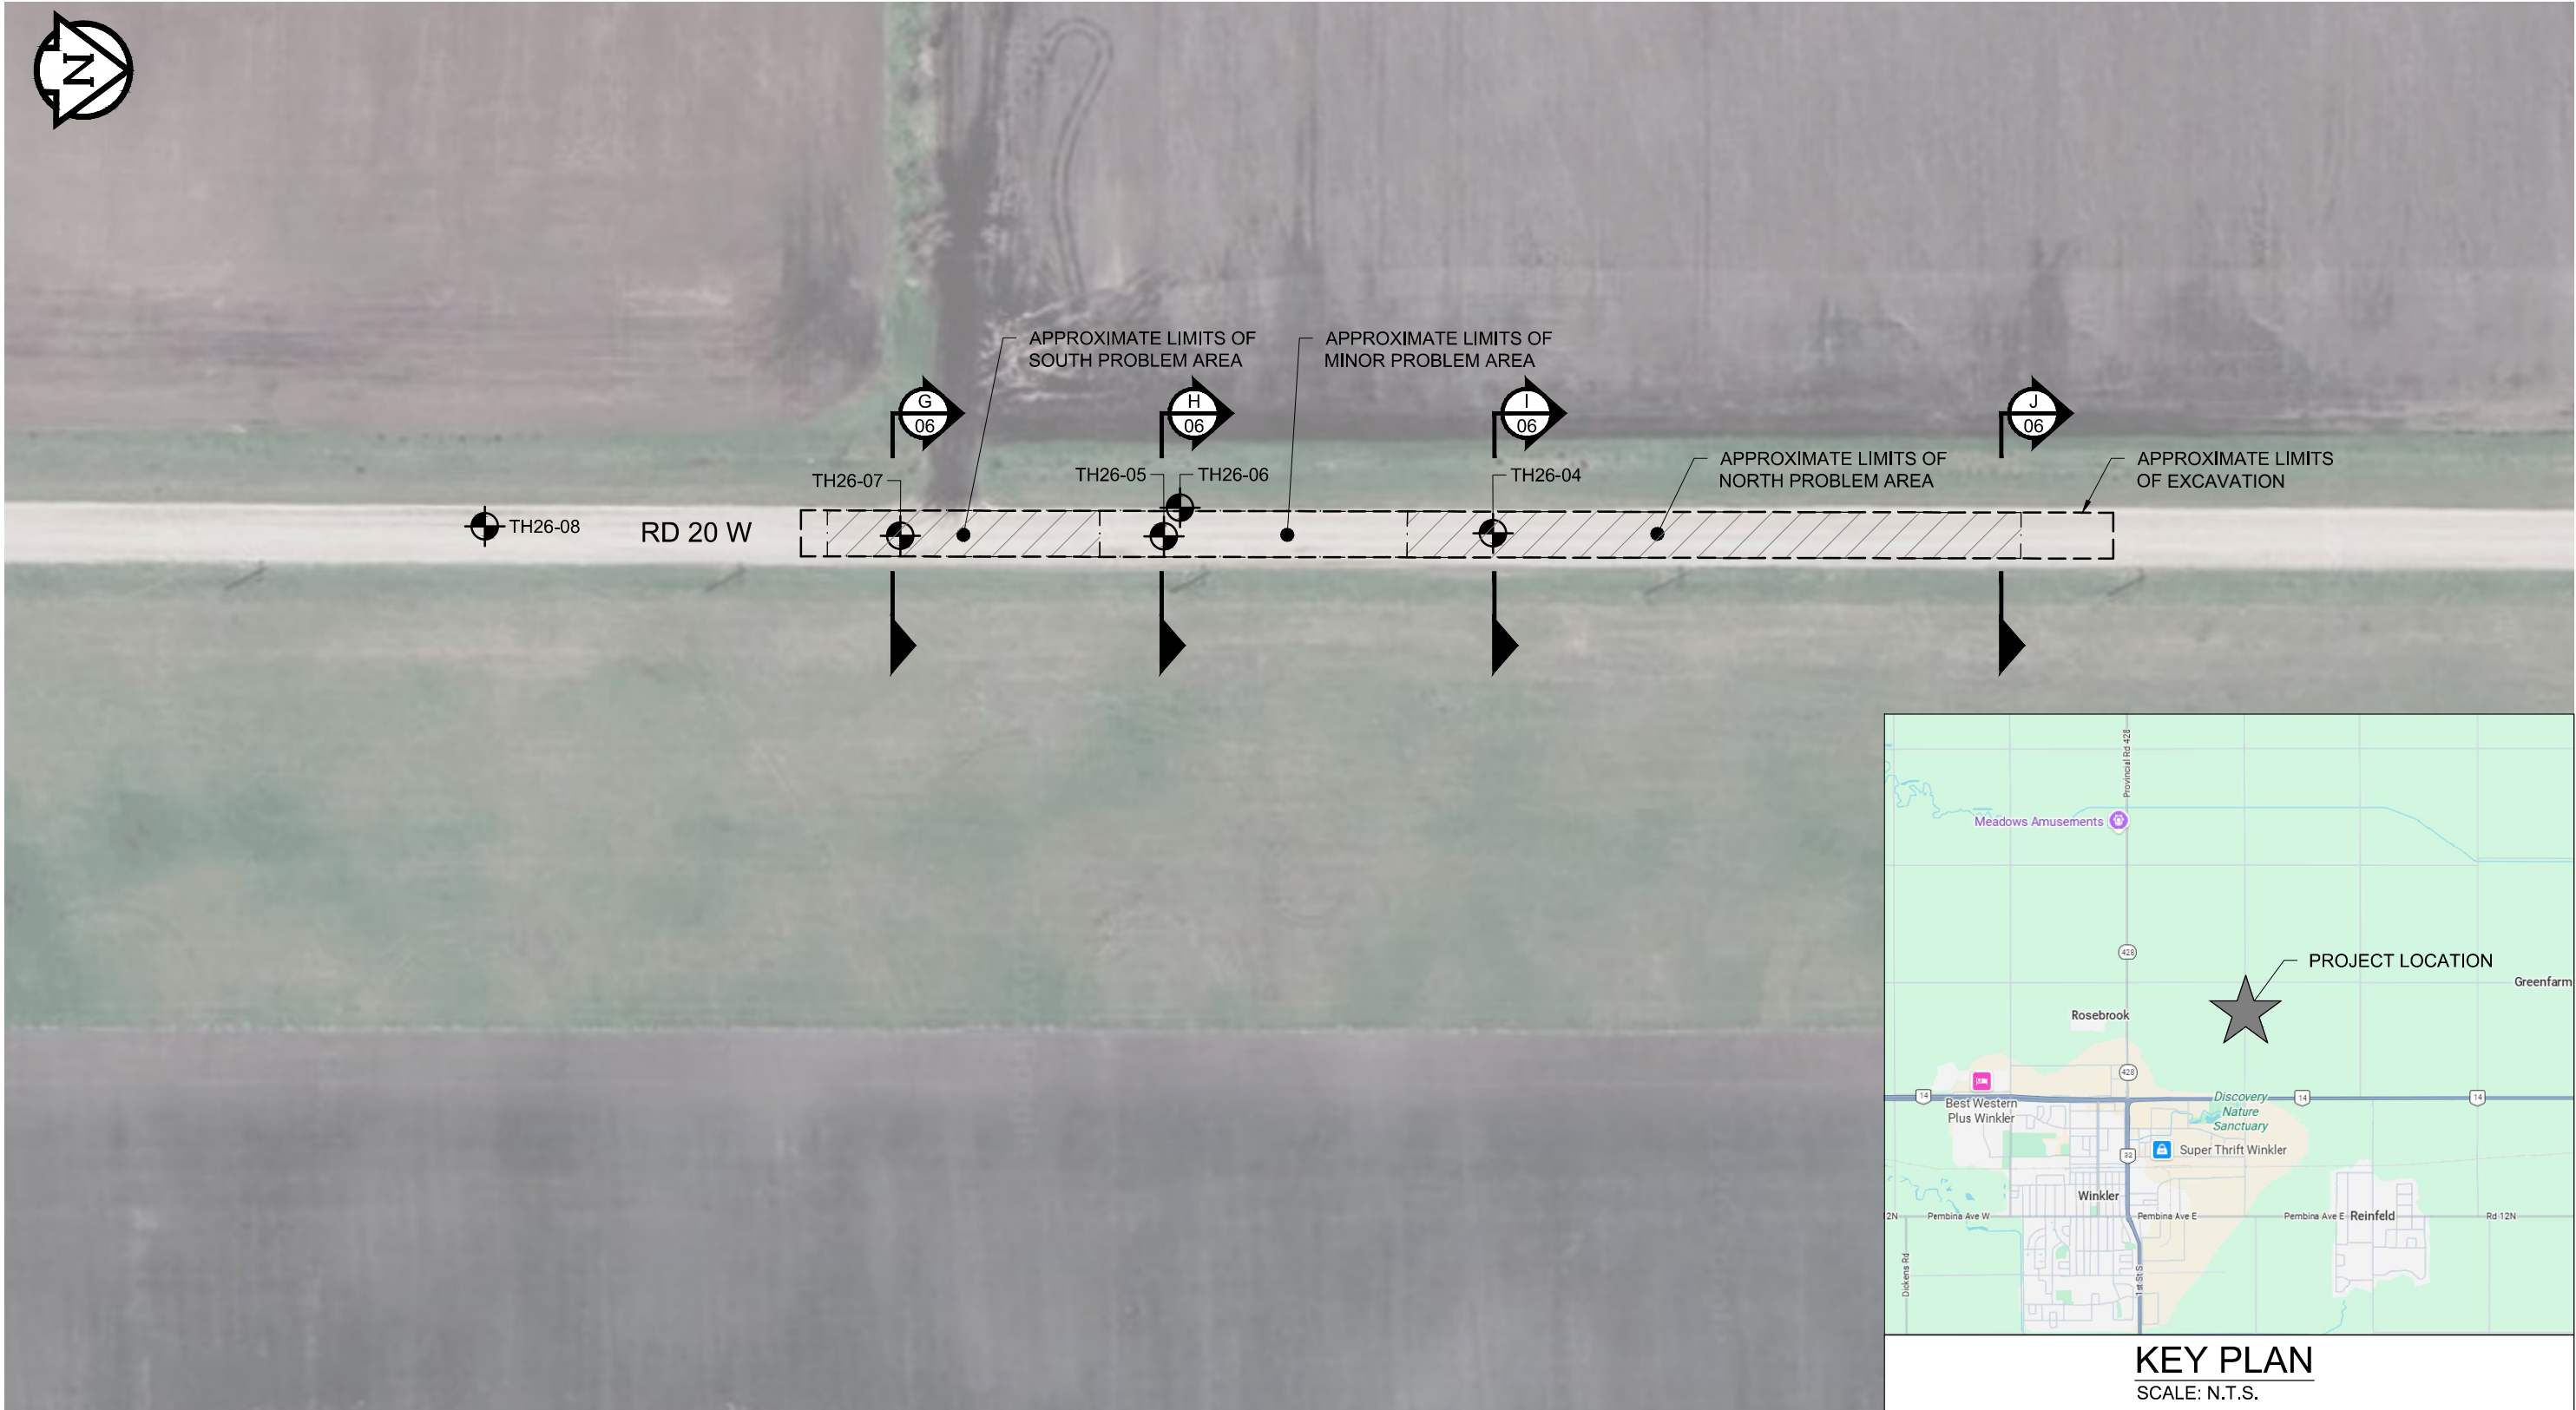
The locations of Test Holes 26-04 to 26-07 are shown on Drawing 05. Stick logs are shown on Drawings 06 and 07. The cut is approximately 7 m wide and 200 m long (personal communication, P. Schroedter). A brief description of the soil stratigraphy and groundwater conditions encountered during drilling is summarized as follows:

North problem area and within cut (TH 26-04), the general sub-surface stratigraphy consists of 0.15 m of traffic gravel overlying ~1.2 m of moist sandy lean clay fill, 0.4 m of TDA intermixed with wet silty sand, and soft to firm wet sand lean clay to the depth of exploration.

Minor problem area and within cut (TH26-05), the general soil stratigraphy consists of 0.15 m of traffic gravel overlying ~1.2 m of moist sandy lean clay fill, 0.6 m of TDA intermixed with wet sandy silt, overlying 0.8 m of soft to firm wet native sandy lean clay, and stiff fat clay to the depth of exploration.

Minor problem area but outside cut (TH26-06), the general soil stratigraphy consists of 0.15 m of silty sand fill overlying ~1.6 m of firm, moist to wet sandy lean clay, and stiff fat clay to the depth of exploration.
